# Manhole Inspection Summary

Manhole # S01WW1015MH

Insp Date: **9/19/06 12:17 PM**

**Location** Address: **6100 PARK HEIGHTS AVE**

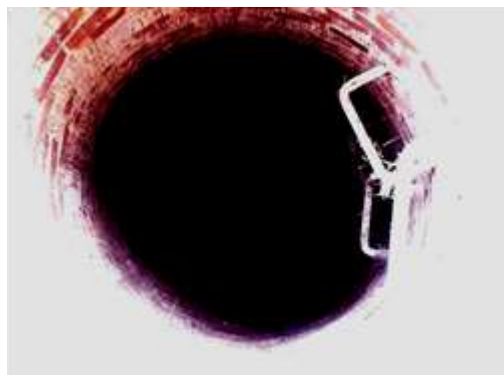
Top View

Comments **Top View picture indicates evidence of infiltration through the Adjustment and the Corbel.**

Infiltration: ☐ None ☒ **Joint** ☐ Cracks ☒ **Mortar** ☐ Roots ☐ Wall

Infiltration: ☐ None ☐ Joint ☐ Cracks ☒ **Mortar** ☐ Roots ☒ **Wall**

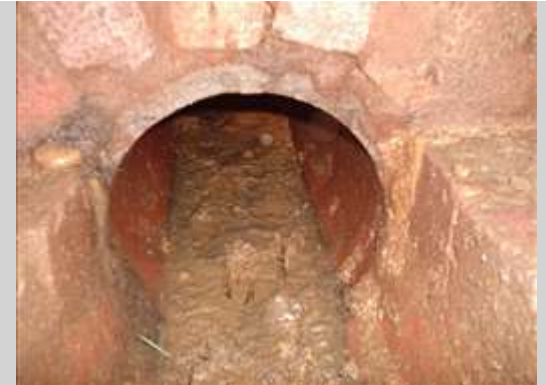
### 8 in. Circular Gravity Sewer Pipe Out @ 12 O'Clock

heavy debris in sewer

Deposits: ☐ None ☒ **Mud** ☒ **Gravy** ☒ **Debris** ☐ Grease

Silt Depth: **2** (in.) Deposits Extent: **Medium**

Infiltration: **Evidence** Pipe Seal Cond: **Unknown**

Rod and Bar (Angled)

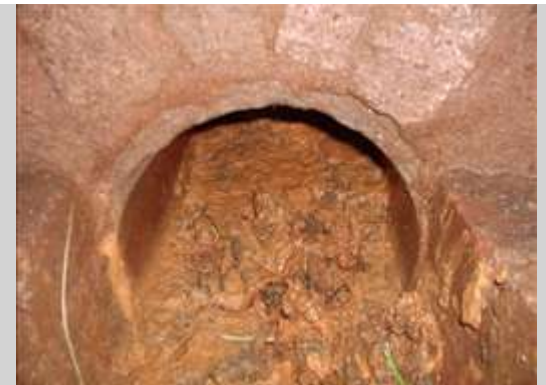
### 8 in. Circular Gravity Sewer Pipe In @ 6 O'Clock

heavy debris in sewer

Deposits: ☐ None ☒ **Mud** ☒ **Gravy** ☒ **Debris** ☐ Grease

Silt Depth: **3** (in.) Deposits Extent: **Medium**

Infiltration: **Evidence** Pipe Seal Cond: **Unknown**

Rod and Bar (Angled)
